Name The Poor HouseMHT# CE-216Location Cecil
COUNTYRising Sun
townBed Pump Rd
address or road#North of R+ 273

the Poor House

HAINES HOUSE (POOR HOUSE)

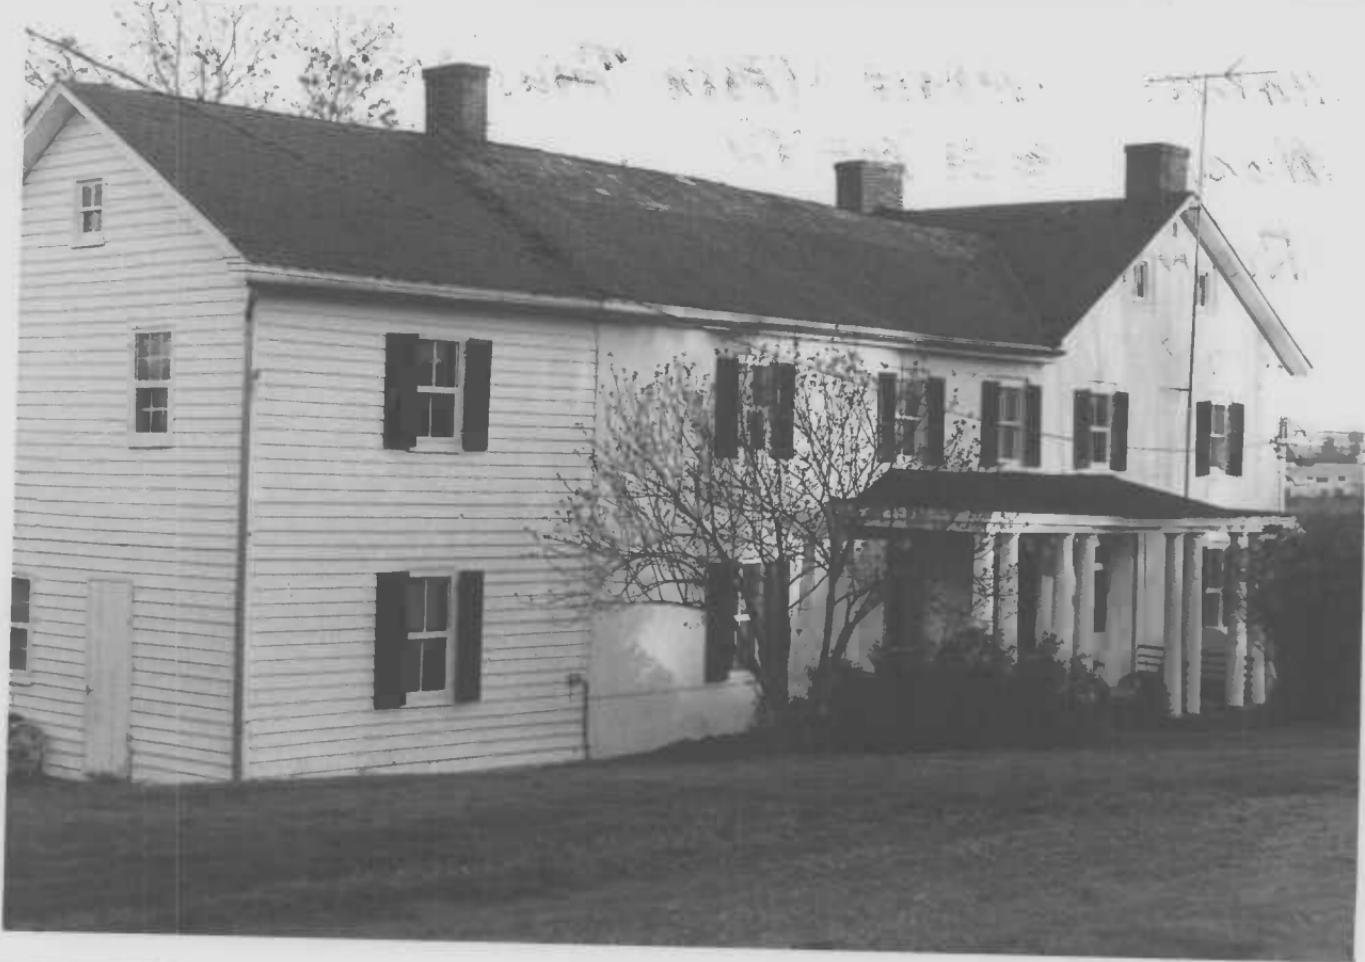
WEST ELEVATION

the north side of the 1767 addition, at right angle thereto. Most of the scsh is $\frac{1}{2}$, some $\frac{1}{6}$ remaining and the shutters are painted on, 1st ^{story} ~~floor~~ + lowerd on 2nd story. The most noteworthy feature of the building on the exterior is the small date plaque on the west gable with the date 1767 ad initials W H L,
